**WORKER EXPOSURES TO AIRBORNE LEAD DURING
RESIDENTIAL REMODELING ACTIVITIES**

RESULTS OF FIVE SITE VISITS

NAHB Research Center, Inc.
400 Prince George's Boulevard
Upper Marlboro, MD 20774-8731

January 15, 1997

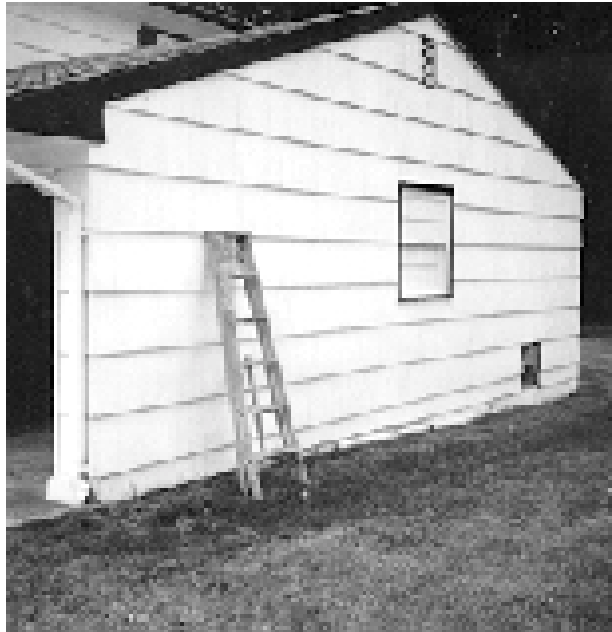
The shingle removal and clean-up took place in August 1993, over a period of just under 3 hours. The home was built in approximately 1960, and is located in a neighborhood of homes of similar construction near the Atlantic Coast of New Jersey. The shingles were being removed from the outside end wall of a garage as the first step in construction of an addition to the home. The shingles were made of red cedar, measuring approximately 3.5" to 4.5" in width, 17" in length, and tapered from 1/16" to 3/8" in thickness. Two layers of shingles were applied along each course, with the vertical lap approximately 2" to 3", and 14" to 15" exposed to the weather. The shingles were nailed to plywood sheathing on 2 x 4 wood studs. The top layer of shingles on each course were painted white, while the lower layer was unpainted. The shingled area of the wall measured 26 feet wide at the base, and ranged in height from about 8 feet at the corners to 12 feet in the center (at the gable peak). The total area from which shingles were removed was about 260 square feet. The paint on the shingles was deteriorating in many locations and showed hairline cracks, but no substantial areas of peeling were observed.

A photograph of the work site appears below.

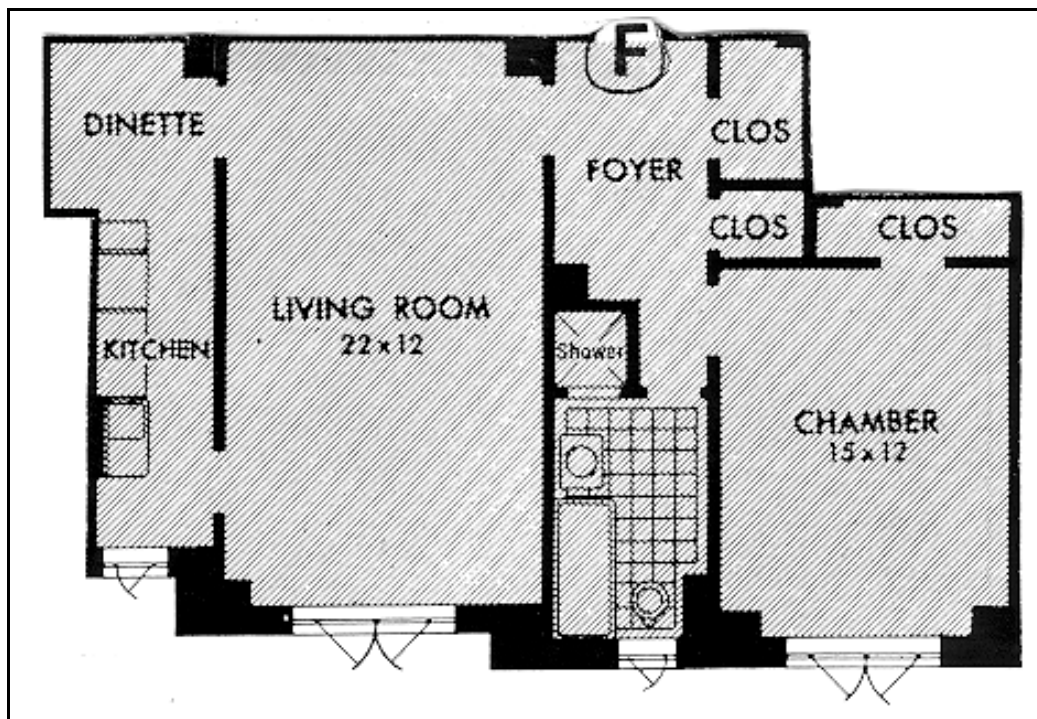
APARTMENT UNIT FLOOR PLAN

The bedroom and the kitchen of this apartment unit were scraped, in that order, during this monitoring project. Paint condition in these two rooms was highly variable. Most of the defective paint in the bedroom was located on one wall, while the kitchen had large areas of paint literally falling off the walls and the ceiling, apparently due to water damage from above. The paint in the kitchen was in the worst condition of any paint in the apartment.

A floor plan for the unit where the work was performed is below. Note that the room marked "CHAMBER" is referred to in this report as the "bedroom."

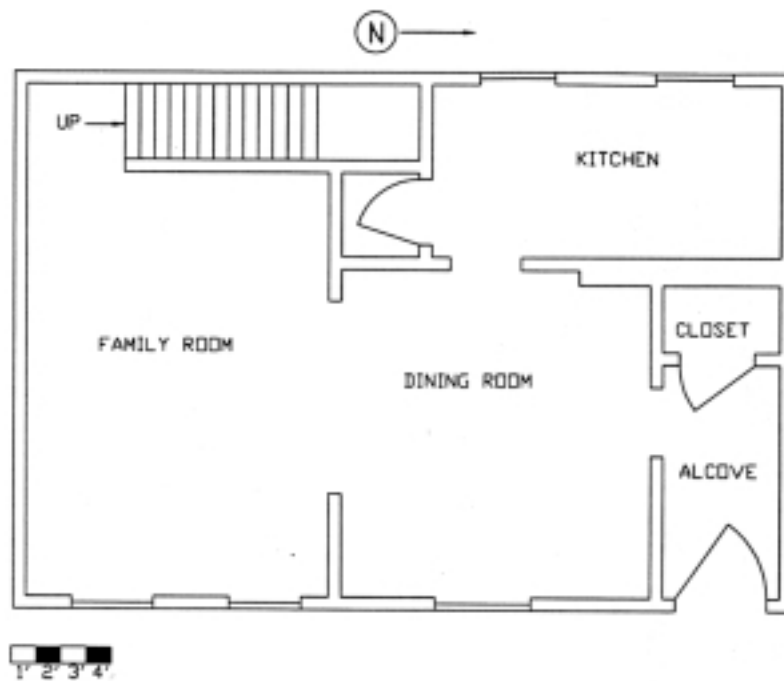
The approximate layout of the job site appears below.

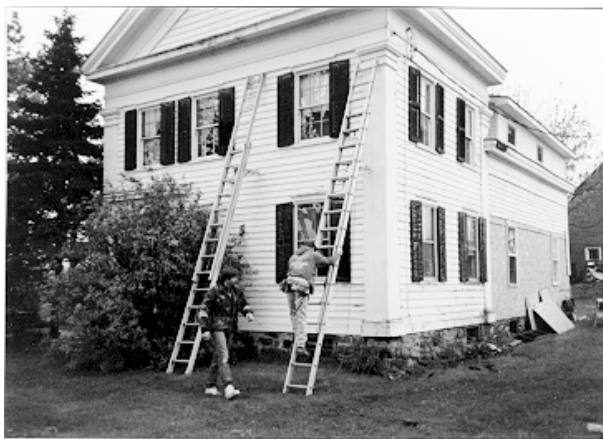
The work monitored during this study involved removal and replacement of a total of ten wood windows in an early-19th century home located in a northeastern U.S. town. The windows were single-hung, single pane site-built units; approximately half of the windows had what appeared to be original sash mounted in the frame, while the other half had a newer style of sash. Based on the window construction details, type of nails used and estimated age of the structure, the contractor estimated the windows to be at least 175 years old. There was no evidence to suggest that any of the window frames (as opposed to the sash) had been replaced since the home was originally built.

A photograph showing the house, including most of the ten windows that were replaced, is below.

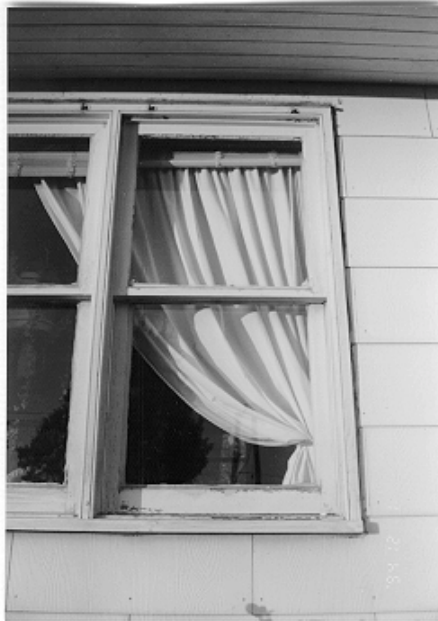
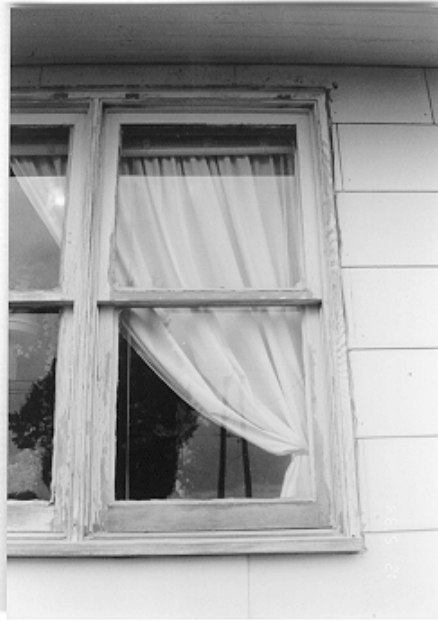
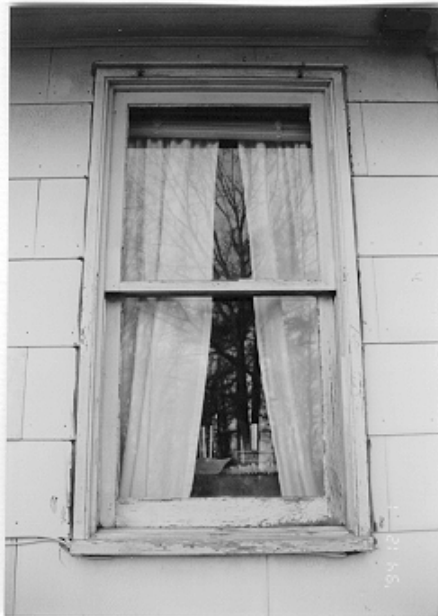
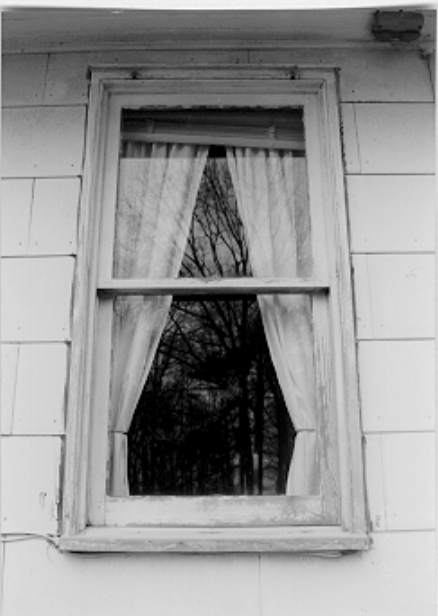
Before and after photographs of two of the windows used in this study are reproduced below.
