FINAL REPORT FOR FIELD EVALUATION OF PATH TECHNOLOGIES

CHAPMAN COMPANIES RANCHO SAN MARCOS SANTA FE, NEW MEXICO

October 2004

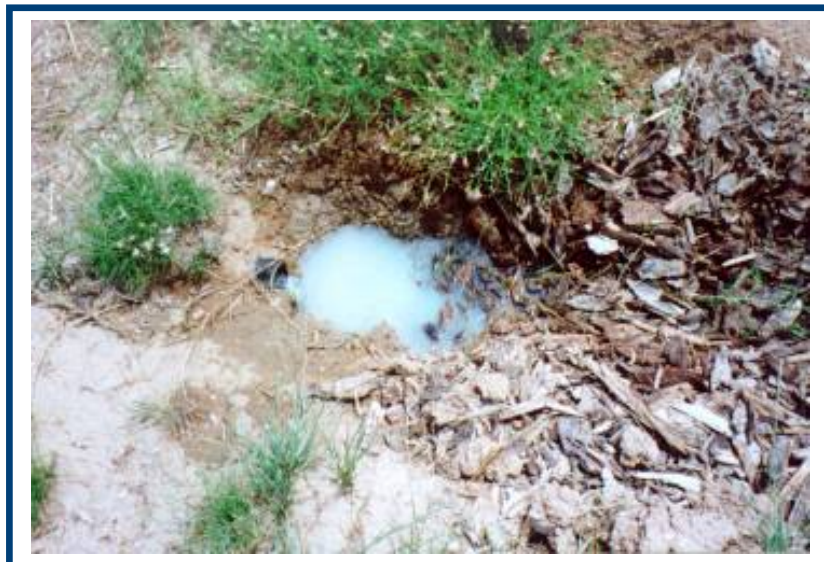
Figure 7 Gray water outlet located in a mulched area. (Uncovered for photo)

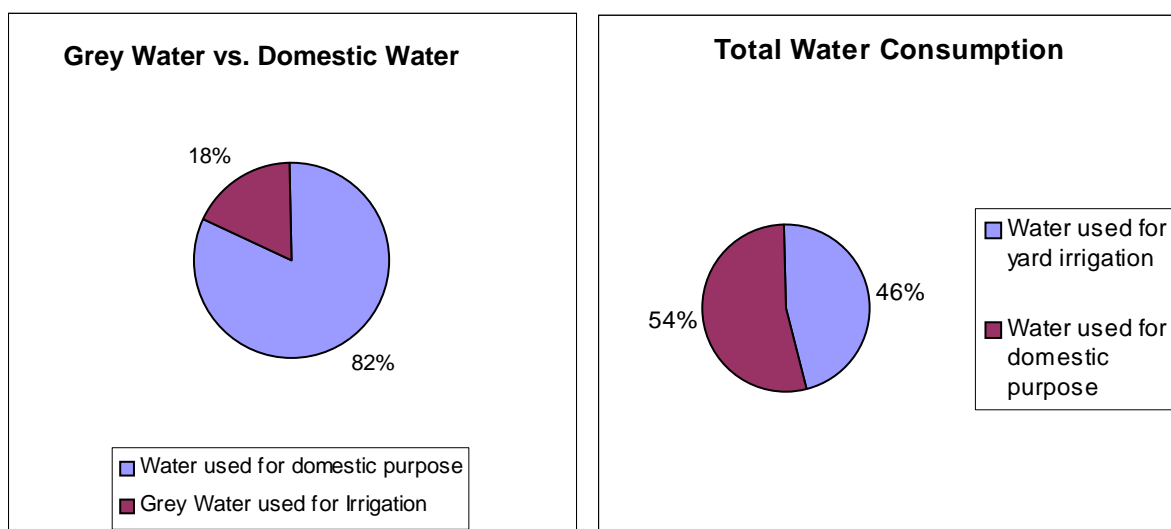
Figure 9 Comparison of water consumption

During the first monitoring period, August through October 2002, total water consumption by the house averaged 162 gallons per day. Of that amount, 37 gallons a day of gray water went to the irrigation of the six-tree orchard. The 37 gallons represents recycled water that normally would have gone directly into the septic system. Instead, the gray water went to irrigate a grove of trees that enhances the beauty of the house and grounds. In the period of August through October 2002 (sixty days), approximately 2,220 gallons of gray water went into the irrigation of the six-tree orchard. Figure 9 illustrates that 18% of the tap water used by the house was recycled into irrigation of the orchard and illustrates the house water used during the first monitoring period for the front and back yard irrigation was 46% of the total household usage. This compares favorably with a household water use study done by American Water Works Association that concluded that, on the average, 50% of all household water usage takes place outside the house.

During the second monitoring period, June through October 2003, 3,973 gallons of gray water went to the orchard irrigation area or about 27 gallons a day.

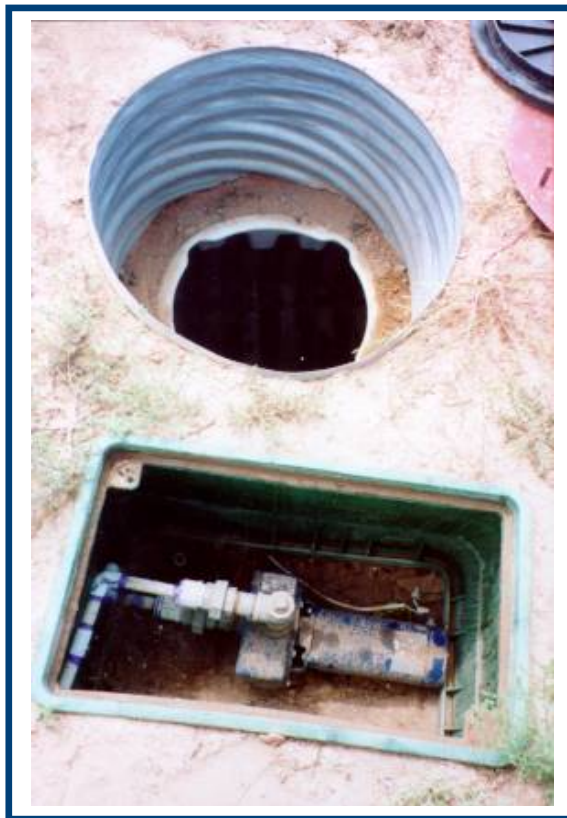
Figure 11 The rainwater collection tank has a ground level access hatch adjacent to the pump

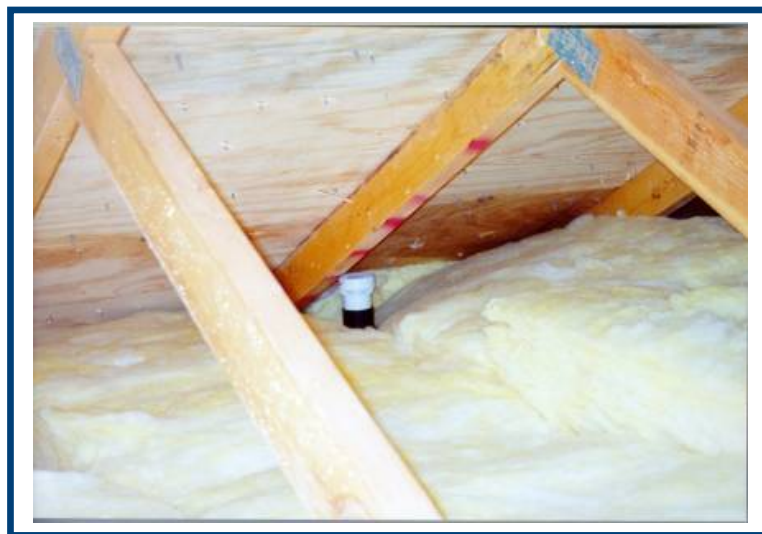
Figure 15 An air admittance valve makes a roof penetration unnecessary

Air admittance vents (AAVs) are pressure-activated one-way valves for plumbing drain, waste and vent systems that allow air in but prevent sewer gas from escaping. Conventional plumbing vents must extend above the roof to minimize odors. AAVs do not need to penetrate the roof, and therefore save labor and material costs. In addition, AAVs do not require lateral branch vent lines, further reducing plumbing labor and material costs. It appears that AAVs offer a significant time and material savings for the plumbing trade. The builder was very interested in using AAVs, since he desired that there be no penetrations to the metal roof.

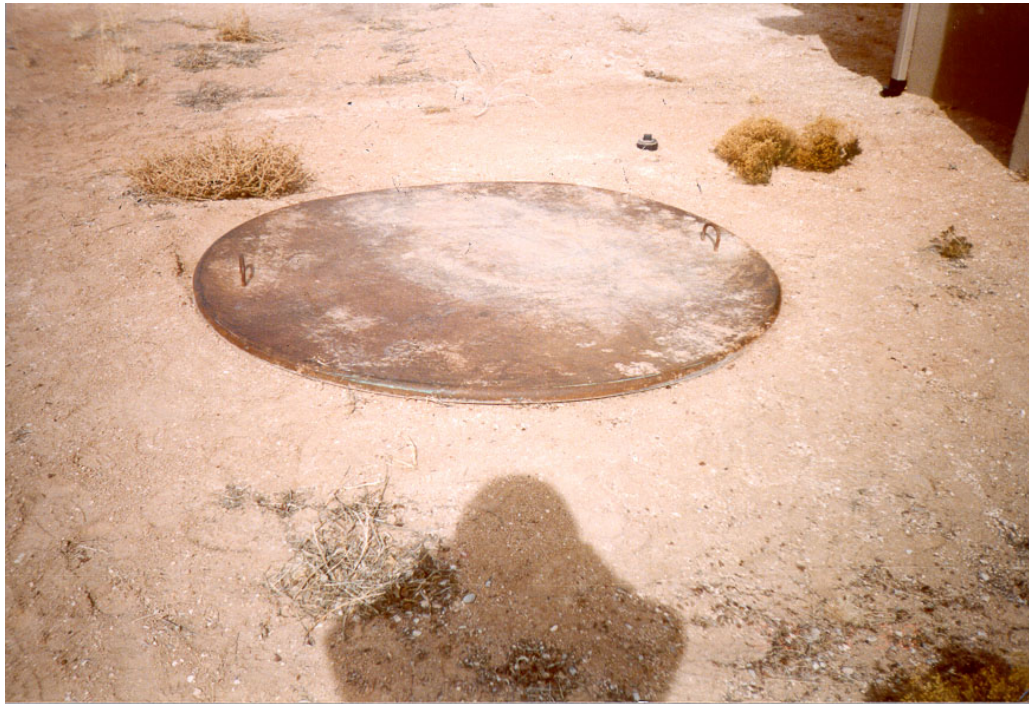
Figure A1 Steel cover for gray water system underground pit.

In order to access the gray water system, first a heavy and awkward steel lid had to be removed to expose the pit. Then one had to climb down into the confined pit to remove the skimmer filter for cleaning, or to turn the necessary valves to perform the sand filter backwash procedure.

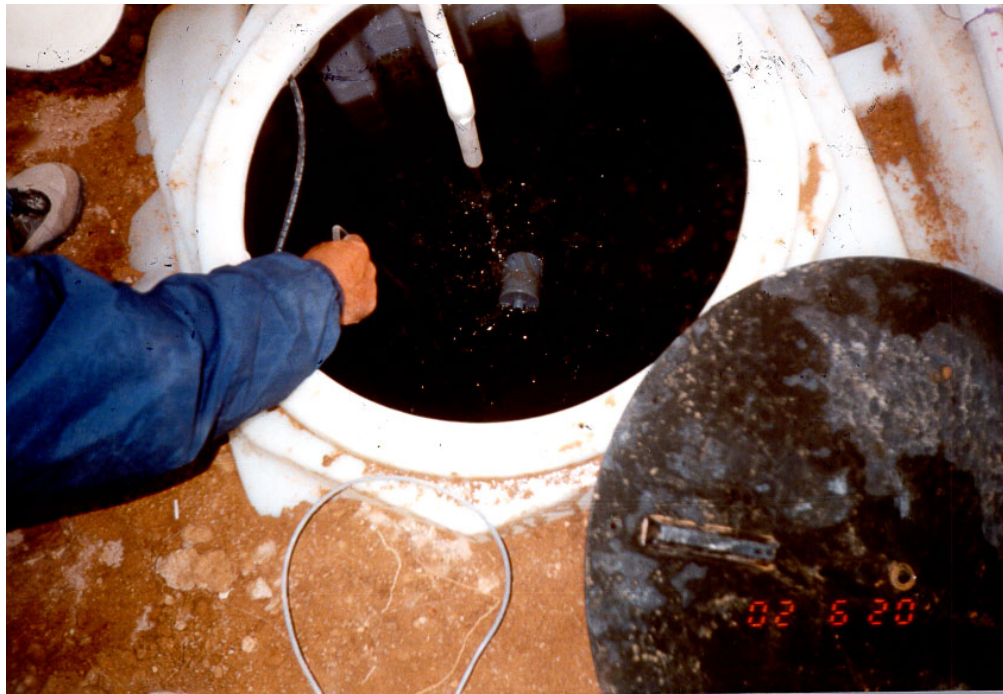
Figure A4 Adjusting the float switch in the new rainwater tank.

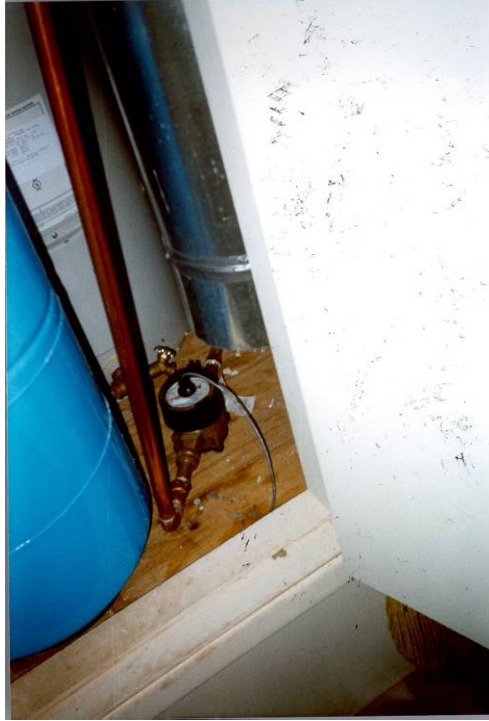
Figure A5 Inside the house, the research water meter monitors whole house water use.

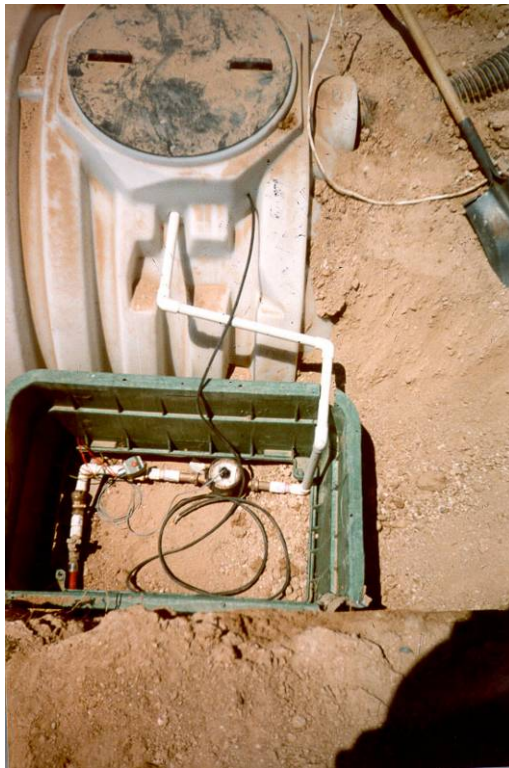
Figure A6 Tap water supply to the rainwater storage tank showing the research center water meter, solenoid valve, and manual shut off valve.

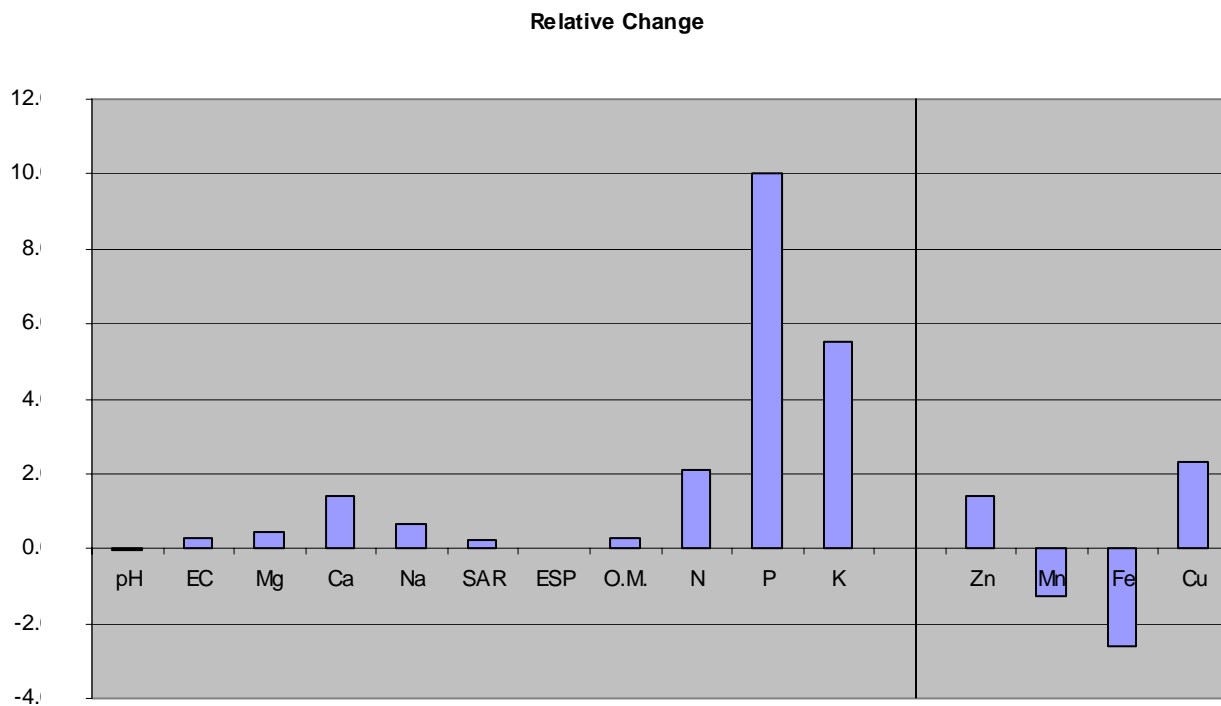
Figure A7 Change in soil conditions at gray water irrigated area

Soil testing results compared to the control samples showed no major increases in macronutrients, micronutrients, trace elements, or salts. Minor increases in nitrogen, phosphorus, potassium and some trace elements occurred. Slight decreases were recorded in manganese and iron. See Appendix for test results and comparisons.
