LABORATORY AND FIELD EVALUATION OF PAN FLASHING/SILL PROTECTION AND WATER RESISTIVE BARRIERS

FINAL REPORT

April 2006

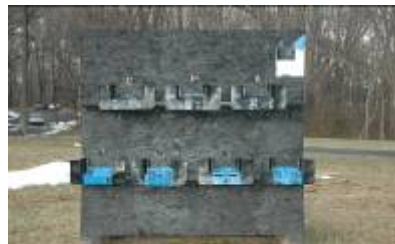
A. Overall view of panels

WBD erected four vertical plywood wall panels, each featuring several small sill pan mockups, outside its testing facility in Maple Glen, Pa. Each panel faced north, south, east or west. The sill pan mockups simulated the types of pan flashings that might be installed in a window rough opening at the sill by using two CAPs joined together with self-adhering flashing membranes. Moisture sensors were placed at the bottom of each sill pan and covered with the flashing membrane.

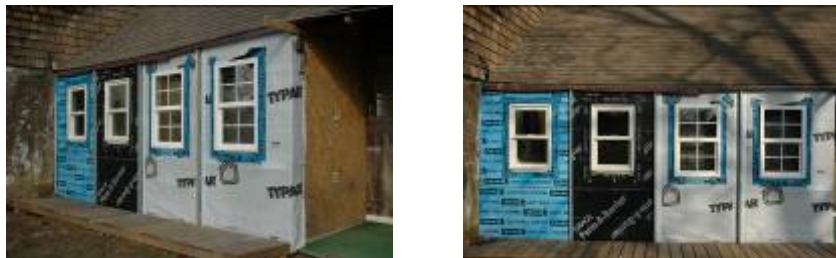
Figure 2. Full-Scale Window Wall Chamber

Construction of the mockup chamber included painted gypsum wallboard, wood studs, fiberglass batt insulation, OSB sheathing, and a wood floor deck, with a climate controlled interior. The steep sloped roof ended near the face of the exterior wall, with no projecting roof overhang. This allowed rainwater runoff to sheet down the exterior face of the mockup's wall and window assemblies.

On the west-facing wall, WBD installed four complete window/wall test assemblies: Panels A, B, C, and D. The panels offered four sets of typical conditions, by combining two different window installation methods with two different window types and two different WRB types (see Table 2).

In February 2005, WBD constructed a full-scale window/wall chamber at its facility to investigate how pan flashing/sill protection approaches work together under real-world conditions. The chamber allowed researchers to test assemblies in an accurate window/wall construction, while still giving them full access to inspect and evaluate performance.

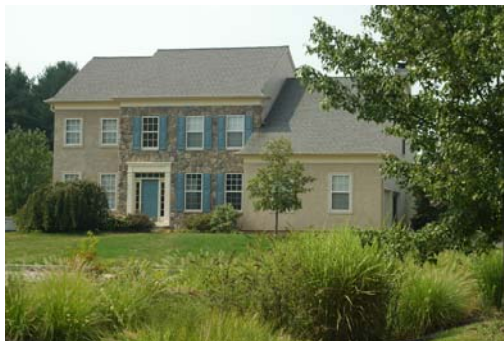
Figure 3. Field Investigation. Single-family Residence in Ambler, PA

The two-story home was built in 1996 and has an attached garage. Prior to remediation, its front elevation was clad with stucco and manufactured stone veneer. The home's underlying wall construction includes oriented strand board (OSB) sheathing attached to

wood stud framing, and a WRB installed over the sheathing. The windows are extruded vinyl, single hung, and have insulated glazing. The roof is covered with asphalt shingles and features aluminum gutters and downspouts.

This project consisted of retrofitting and monitoring a single-family residence that had experienced water intrusion.

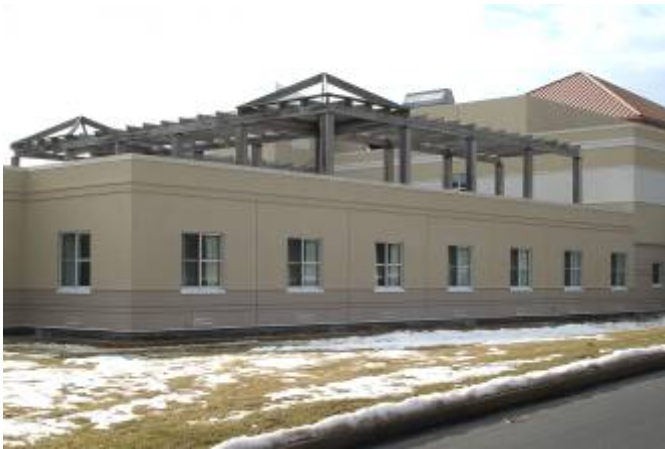
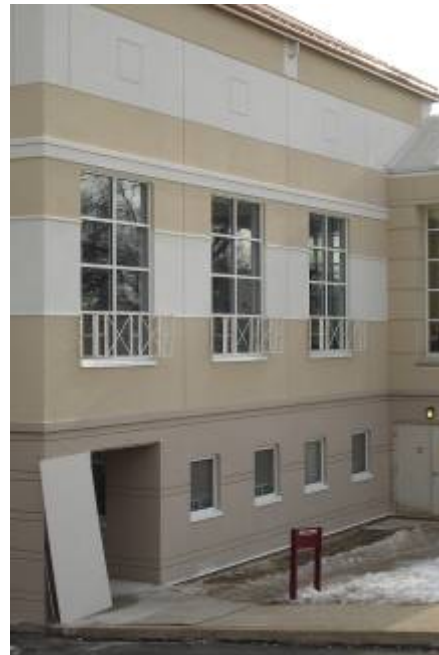
Figure 4. Field Investigation. Health Care Facility in Eagleville, PA

Results. No sensors recorded any water intrusion, and neither the building's owner nor project personnel observed any evidence of water intrusion. Refer to the data tables in Appendix D.

The sensors allowed monitoring of moisture penetration at the windows for 41 weeks between December 19, 2004 and November 19, 2005. During the week of December 9, 2004, data was only available from the west elevation sensors; and during the week of January 9, 2005, data was only available from north elevation sensors. Otherwise, weekly readings are available for both elevations (See Appendix D).
