EIFS Review Committee

Water Intrusion and Remediation for Wood Frame Homes with Exterior Insulation and Finish Systems (EIFS)

*A Question-and-Answer Information Sheet
 for Home Owners*

Third Edition - January 1999

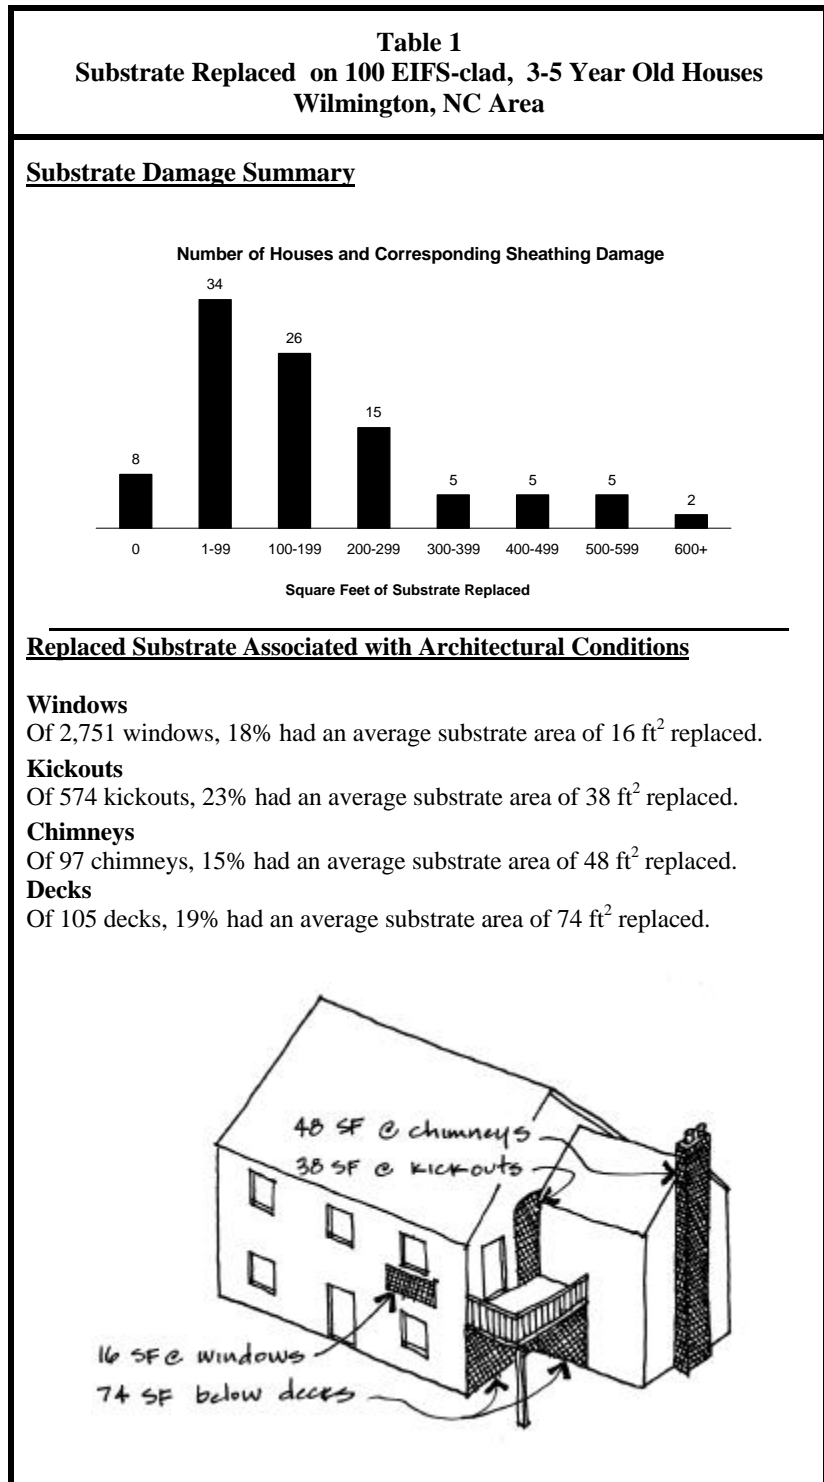
Damage can be significant if moisture intrusion goes undetected. See Table 1 for statistics on damage. Damage can become more serious if allowed to continue over time.

Source: Williams Building Diagnostics, Inc. - 1997
