**FINAL REPORT FOR PATH  
FIELD EVALUATION OF  
RESOURCE & ENERGY EFFICIENT  
CONSTRUCTION**

**ARUNDEL HABITAT FOR HUMANITY  
ANNAPOLIS, MD**

Prepared by  
NAHB Research Center, Inc.  
400 Prince George's Blvd.  
Upper Marlboro, MD 20774

October 2003

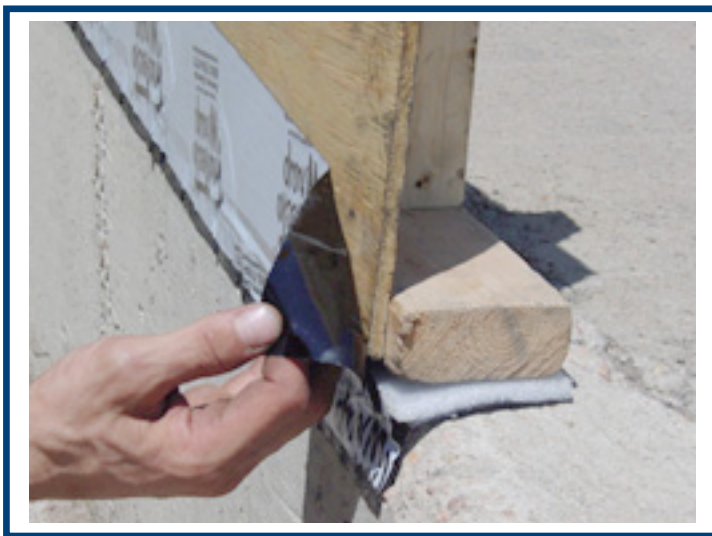
Figure 3 - Protecto Wrap® sill plate seal with integral adhesive for an air and water seal

However, major air leakage points through the building envelope should be sealed. Therefore, the execution of this practice should begin with specific design details on the architectural plans, so that potential air pathways can be blocked as the house is being built. Platform framing, with common configurations of wood materials, suggests that there are quite a few junctions or intersections that one could predict to be “leaky”. Universal details should be specified and addressed during the construction process. As an example, the air leak area detailed at the upper arrow in Figure 2, could have been sealed with a continuous bead of glue applied to the top edge of the band board at the time the subfloor was laid. The leak depicted by the lower arrow is easily handled with caulking from an unfinished basement at any step in the construction process. But, a more systemic approach would be to specify a product, such as that shown in Figure 3, to seal critical assembly junctions against air and water penetration.
